**SOUTHEASTERN ALASKA
Oceanographic Conditions
and
NOAA's Twenty-One Year Oil Spill Response History (UPDATED)
(1979-2000)**

**John Whitney
NOAA Scientific Support Coordinator for Alaska**

HAZMAT Report 20001-1

September 2001

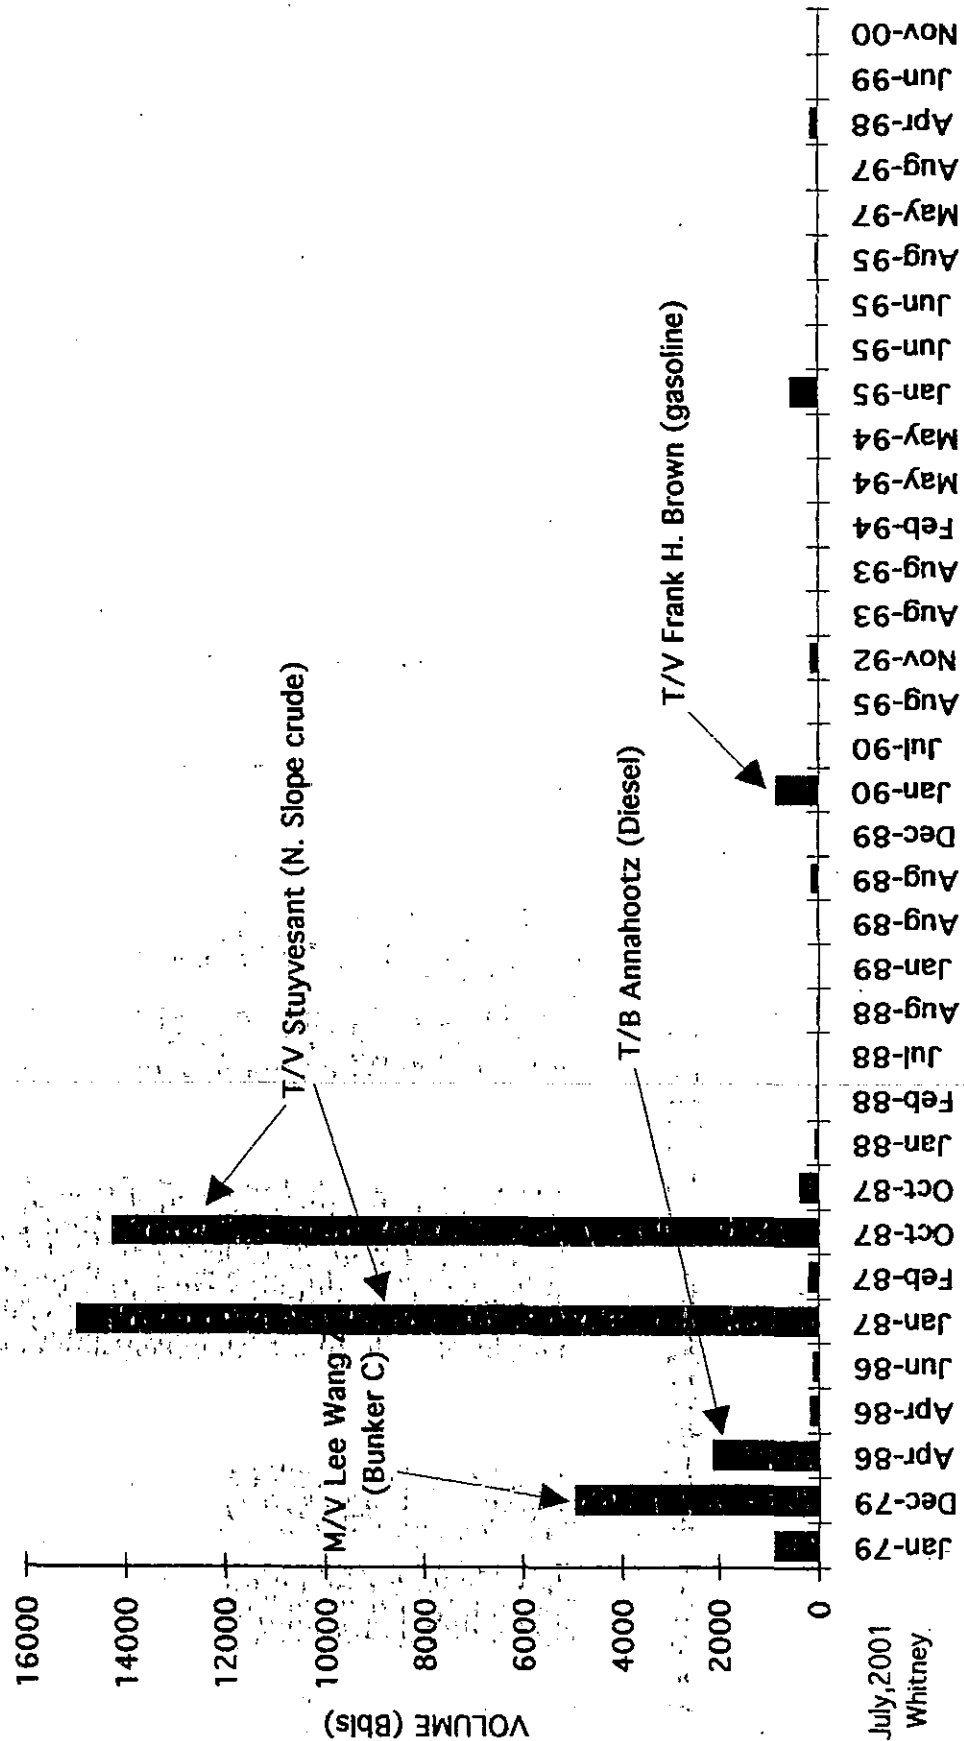
Figure 25

As illustrated by Figure 25, these three incidents were all so large volume-wise that many of the other 33 incidents hardly register on the same oil spill volume graph. Removing these three incidents, however, results in Figure 26 in which the more frequent oil spill in SE Alaska plots anywhere from less than 100 bbls to around 1000 bbls. When the T/B Annahootz grounded in Wrangell Narrows in 1986 under 35 knot wind conditions, an estimated 2143 bbls of diesel was released. Roughly fifteen hours later the Coast Guard conducted an overflight and found no visible signs of the spill and no impacts were observed.

Southeast Alaska OIL SPILL VOLUMES: '79-2000 (NOAA supported spills only)

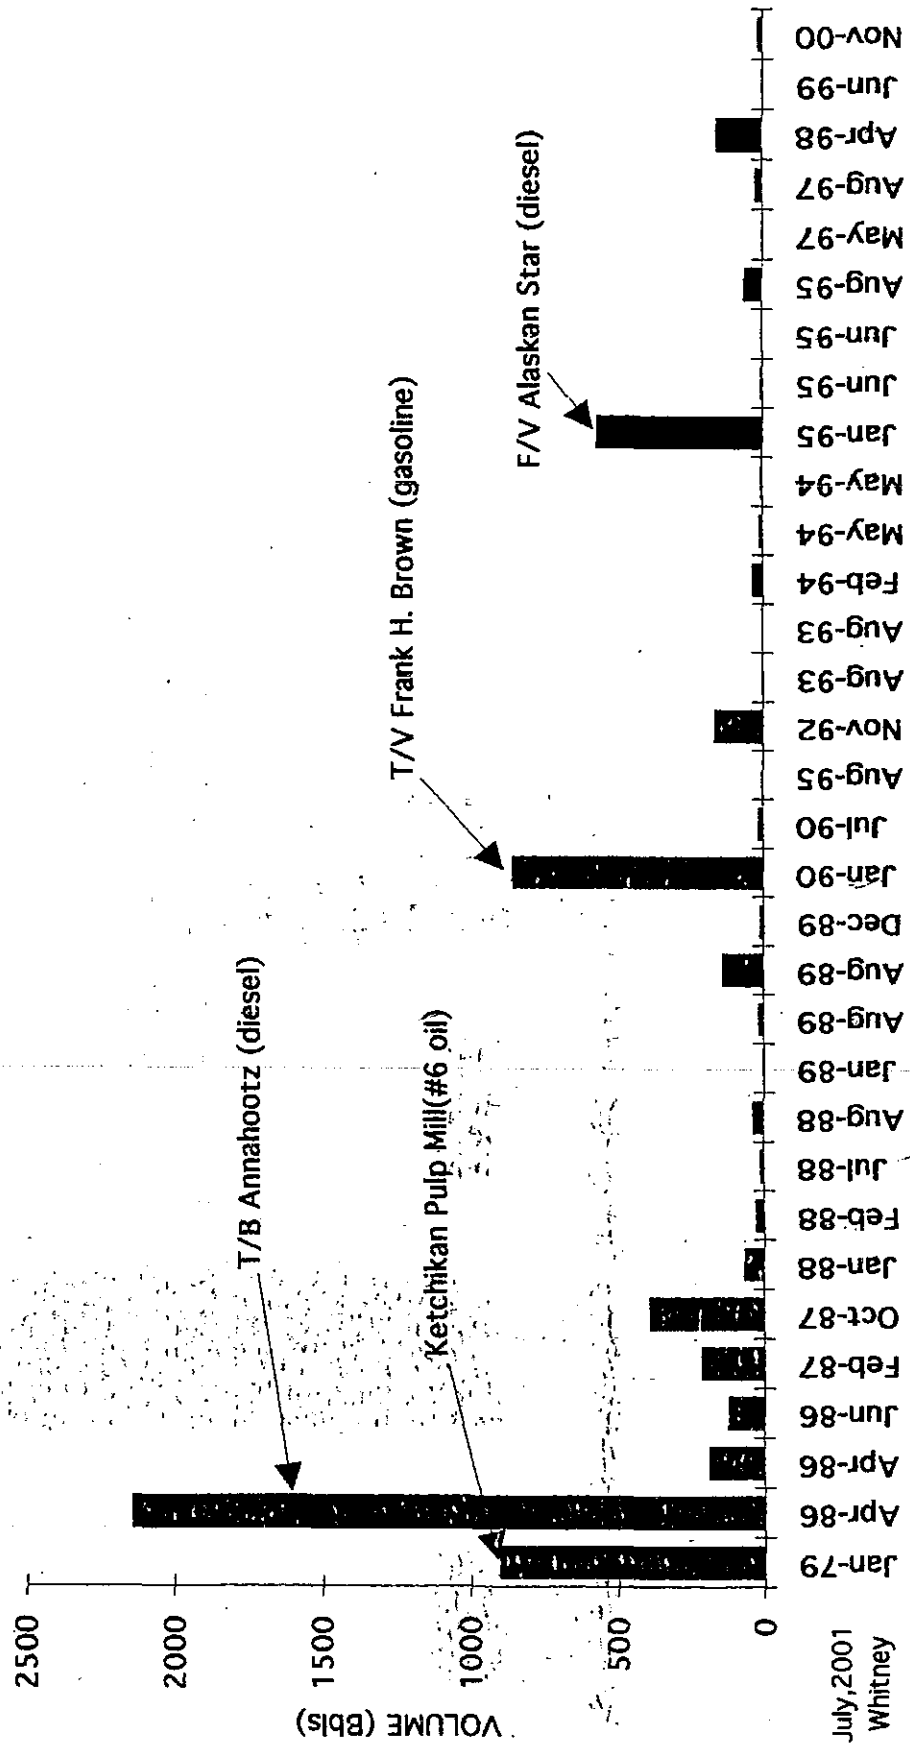
Figure 26

Southeast Alaska
OIL SPILL VOLUMES: '79-2000
(excluding the three largest spills)

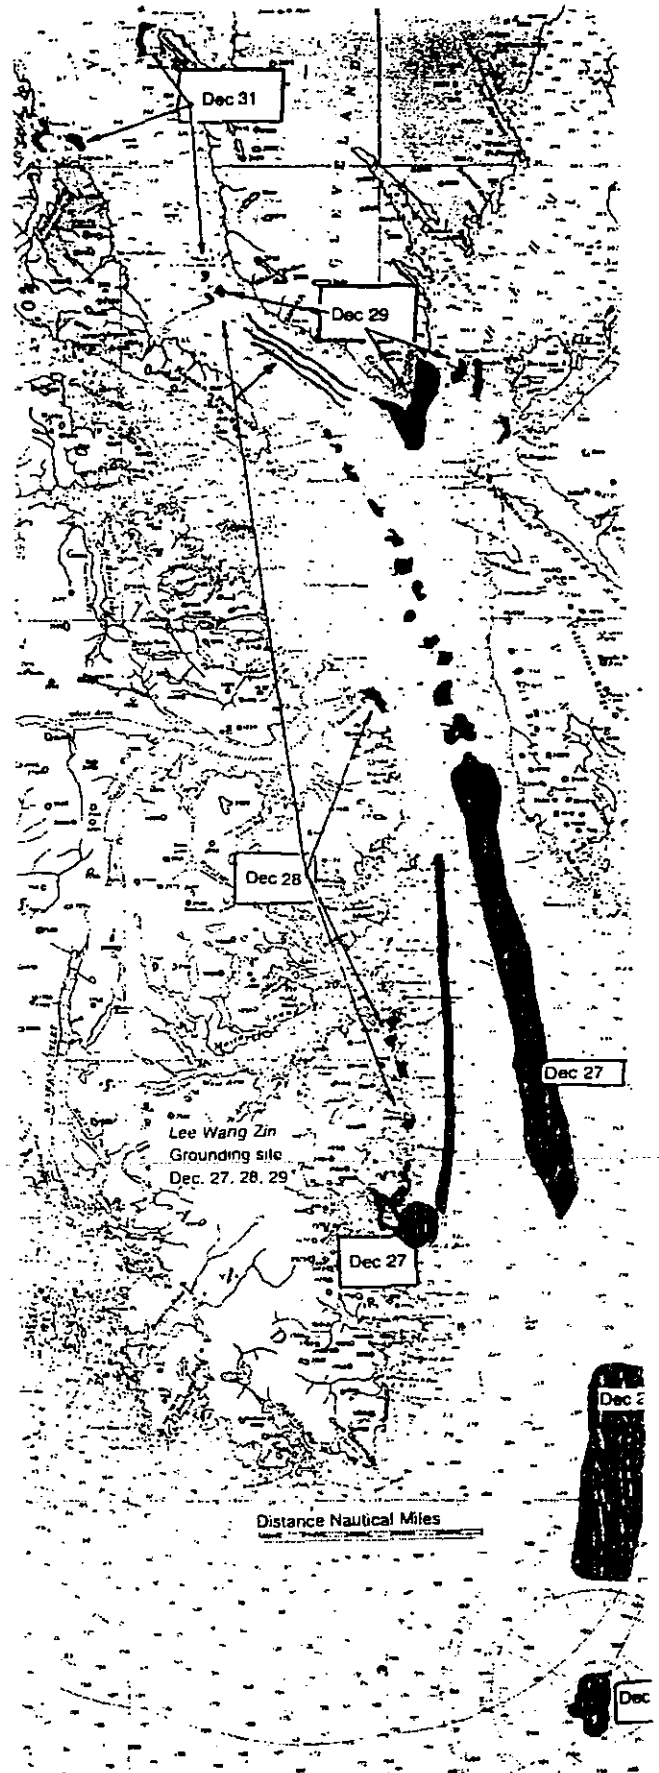
Figure 1. Oil movement from the *Lee Wang Zin*, December 1979

vessel leaking oil badly, with a 0.5-mi radius of oil around the grounded ship, and two large slicks going northward up Clarence Strait, extending 35 mi, as shown in Figure 1. Only one or two aircraft could fly on that Thursday. Later that night, winds gusted to 90 kt.

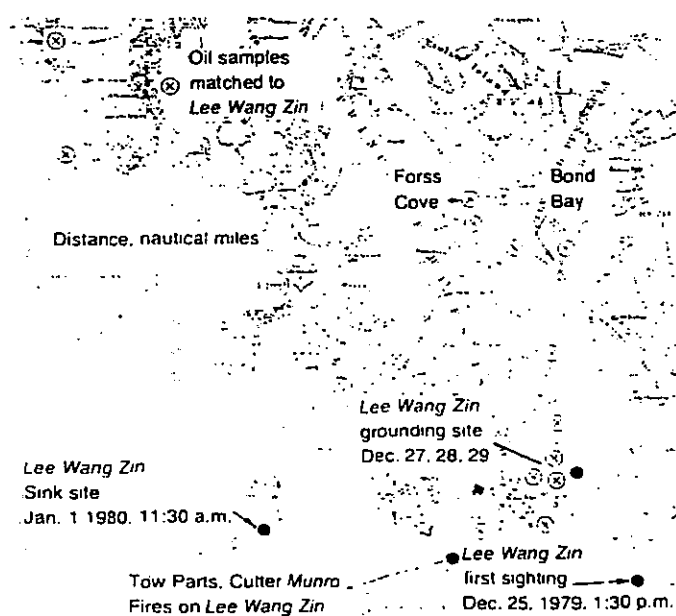
Figure 2. Locations of oil samples matching oil spilled from the *Lee Wang Zin*.
